**Fish Passage Inventory and Barrier Assessment on
U.S. Fish and Wildlife Service Lands:
Watershed Resource Inventory Areas 1-23**

**U.S. Fish and Wildlife Service
Western Washington Fish and Wildlife Office
Division of Fisheries and
Division of Watershed Protection and Restoration
Lacey, Washington**

February 2004

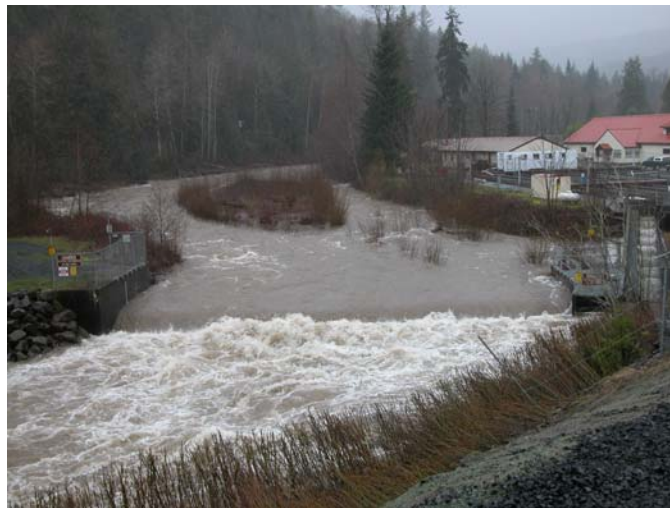
Figure 5. Electric weir at Quilcene NFH on 10/22/03, almost completely submerged during high flows. This is the starting point for the full physical survey on the Big Quilcene River.

When turned off the electric weir acts as a full physical block during low flows; however, an ancillary fish ladder is present. The weir is also a barrier when the electricity is turned on during the first high water event while coho are running, from approximately October 1. The weir is turned off, or de-electrified, after the fall chum runs end in early January. There is full adult fish passability after January 1 for steelhead, cutthroat, and rainbow trout. Between 230 and 599 adult coho salmon from throughout the run are passed intentionally upstream of the weir by hatchery personnel. Occasionally, adult chum or coho may get past the weir during a combination of high flows, power outages, and other failure of the electric weir (Zajac 2002). The electric weir at the hatchery has a 1.5 m long slanted concrete surface with a slope of 2.5%, and two vertical drops (Appendix A, p.62). The vertical distance from the top of the weir to the slanted surface is 0.45 m, and the vertical distance from the bottom of the slanted surface to the water surface is 0.60 m. At low flows, adult salmonids can navigate the first jump, but can not swim up the slanted portion. At high flows, the two vertical drops and the slanted portion of the weir become submerged, making it fully passable to adult salmonids if the electricity is shut off (Figure 5). The top of the weir has electrodes placed in the concrete that create a graduated current dependant on water levels passing over the weir (Zajac 2002). On the left bank side of the weir is an ancillary fish ladder that was inoperable and not fish passable because of accumulated sediment.

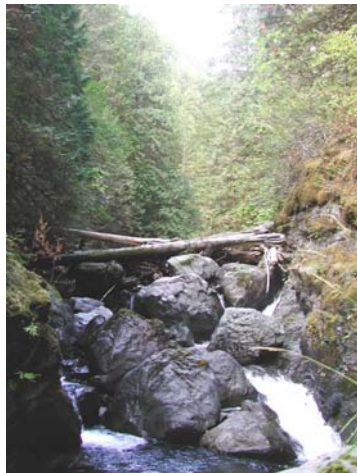
Figure 7. First natural barrier encountered at RK 9.9, hip chain survey stopped here

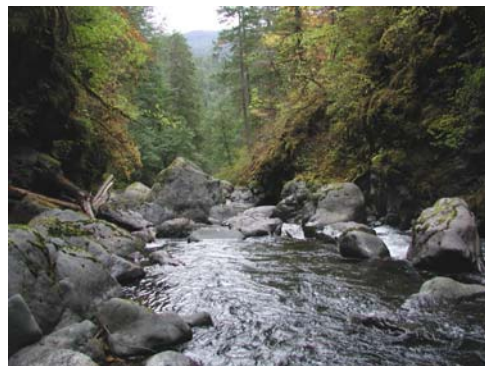
Figure 8. Example of habitat between RK 8 and RK 11.2

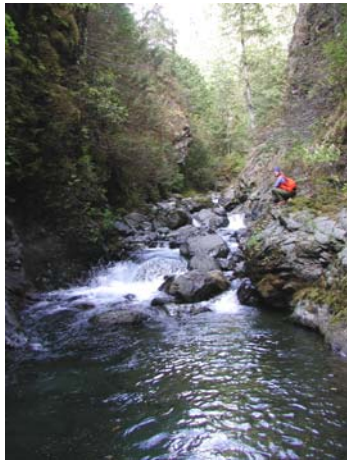
Figure 9. Habitat below first waterfall barrier, approximately RK 9.4

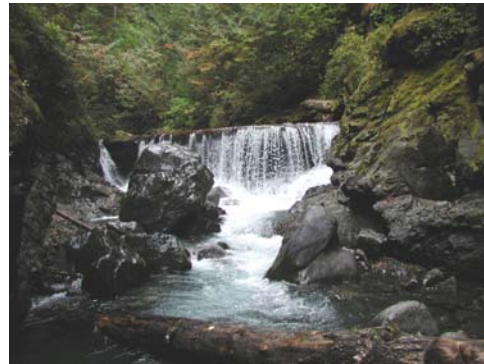
Figure 10. Log falls approximately 0.8 kilometers downstream of documented waterfall at RK12.1

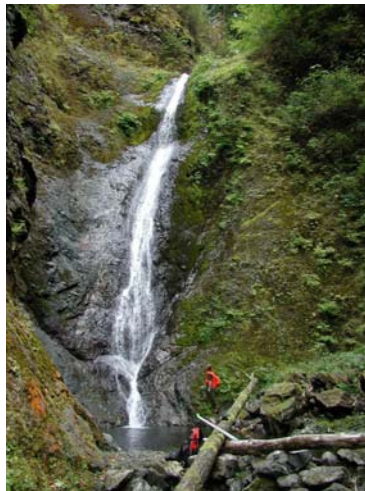
Figure 11. Waterfall on Mile and a Half Creek, measures 26 meters high
